### *Renewal of chainplates on a Hurley 22 (700)*

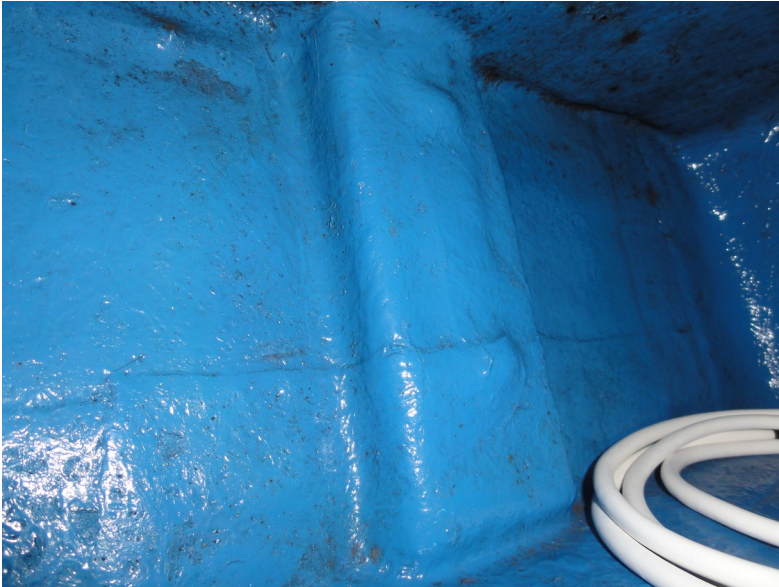
The chainplate design for the shrouds and backstays of the Hurley 22 is basically a sound one and cheap to produce as well. The chainplates are simple bars of flat steel bolted to a backing plate of plywood. They stick up through a slot in the deck and are heavily glassed over together with the hull-to-deck joint. The area of the hull where the chainplates are attached also has an extra layer of fibreglass for reinforcement. This design however depends on a tight seal at the deck to avoid any ingress of water as the fibreglass forms a pocket from which water cannot escape.

*Original chainplate assembly glassed over in a cupboard (fwd lower shroud)*

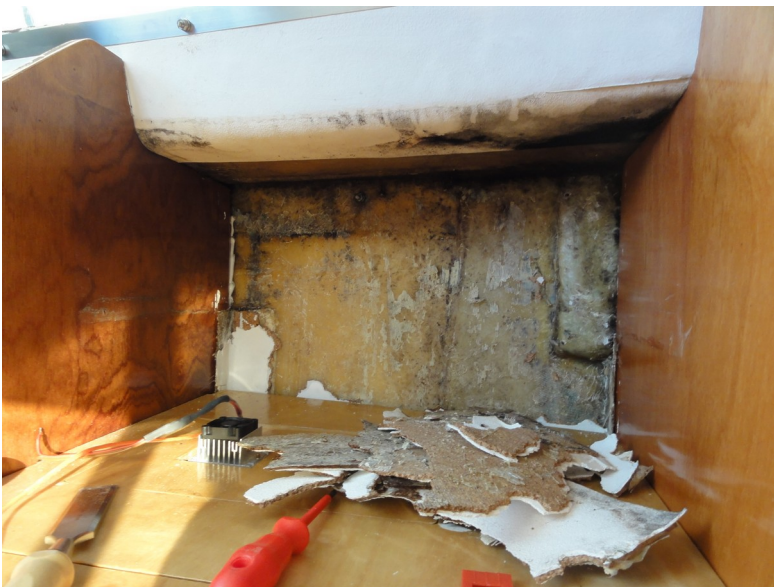
After 40 years of service, my Hurley 22 (No. 903 of SCM) showed some streaks of rusty discoloration on the deck next to the chainplates. What could be seen of the steel looked perfectly fine, however I had some doubts and decided to investigate. Some of the chainplates are not easily accessible and several cupboards and insulation needed to be removed. Holes were drilled into the lower part of the fibreglass pocket and, sure enough, water poured out of the ones which showed rust on deck. The smell of it indicated that rot had already attacked the wooden backing of the chainplates.

*Chainplate pocket visible next to bulkhead on the right in the galley area after removal of cupboard and insulation*

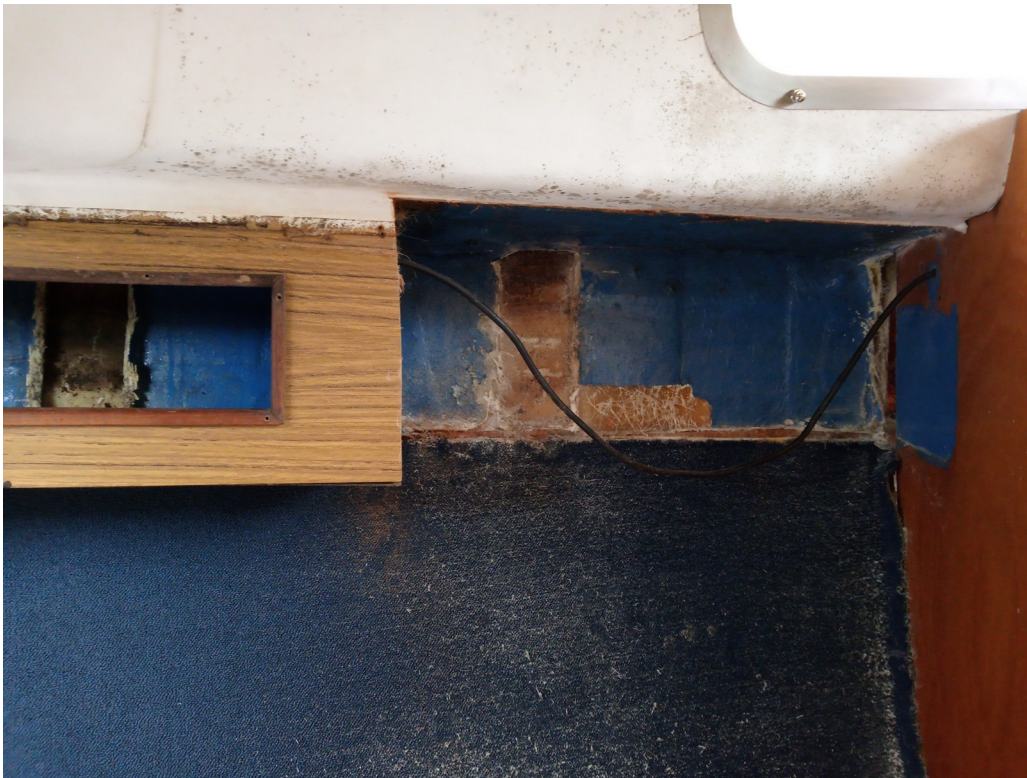
*After removal of the chainplates (and a cupboard)*

The plywood was structurally still sound, however the steel showed clearly where corrosion had set in. Just below deck level it was pitted and some material had already gone.

After draining the water, an oscillating saw was used to cut the pockets from the hull. This was not an easy task as you need to work in the cupboard and the main bulkhead is in the way. It was obviously installed after the chainplates were in.

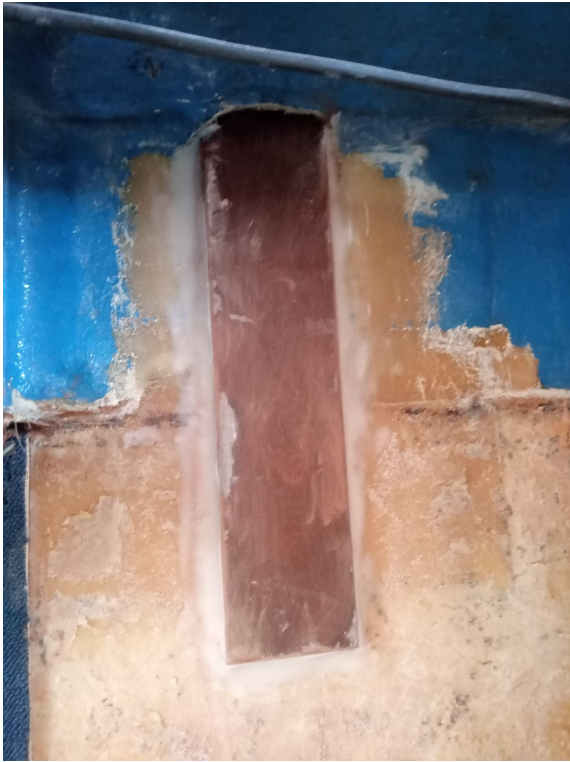
*New plywood backing plate glued in (upper shroud)*

After drying, cleaning, and sanding the hull area where the old chainplates had been, new plywood blocks were glued on with thickened epoxy, and covered with peel ply to give nice rounded edges. After curing this was glassed over with an overlap of about 50 mm to the hull. I always cover any fibreglass work in peel ply afterwards because it smoothes everything out, removes excess resin, and ensures there are no sharp edges or needles afterwards. It is also very satisfying to remove!

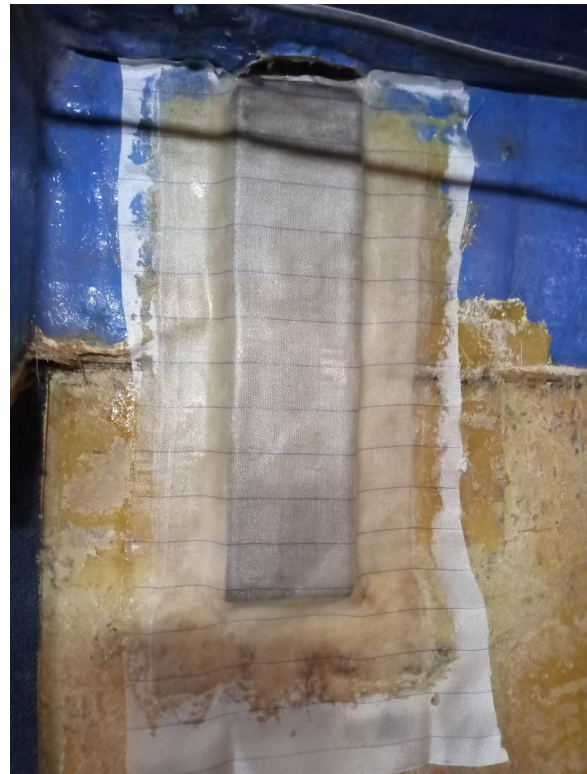
*Glassed over and covered in peel ply*

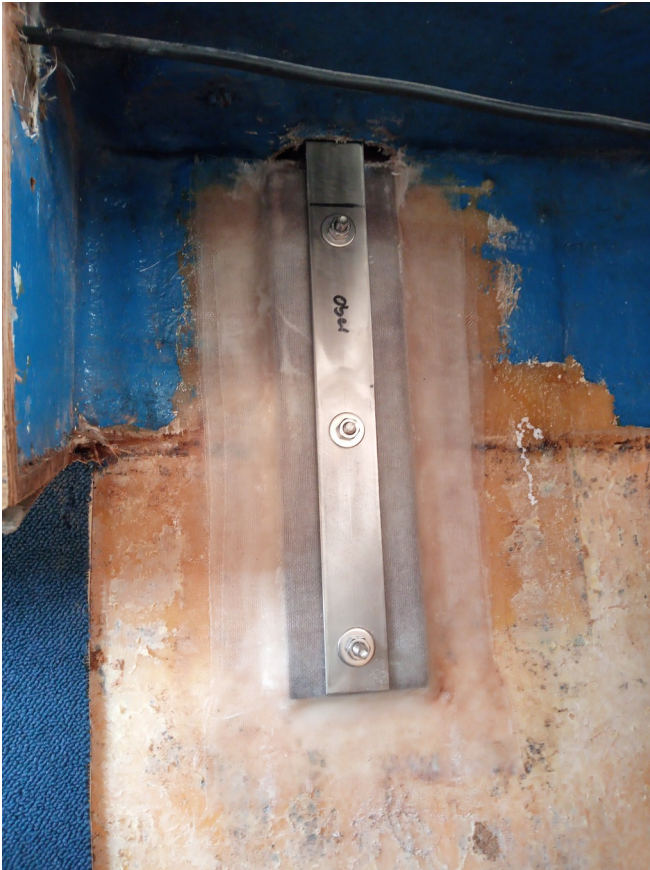
*Chainplate for upped shroud installed*

As the original chainplates looked a bit flimsy to my engineering eye, and guided by the books of John Vigor [1], I decided to upgrade. Steel bar of the type 1.4751 (or AISI 316Ti) with a cross section of 40x4 mm was chosen. 1.4404 (AISI 316L) would have sufficed which is a little easier to machine but that was not available at the time. The chainplates for the upper shrouds were cut to 450 mm length and the ones for the lower shrouds to 300 mm. Three holes were drilled for the bolts which are M10, another for the shroud attachment, and the upper end was rounded.

As I wanted to be able to inspect the chainplates in service, I installed them on top of the plywood-glass-sandwich instead of encapsulating them as in the original design. This also allows any water to run off. I also wanted to make better use of the local hull reinforcement by bolting the chainplates through the hull.

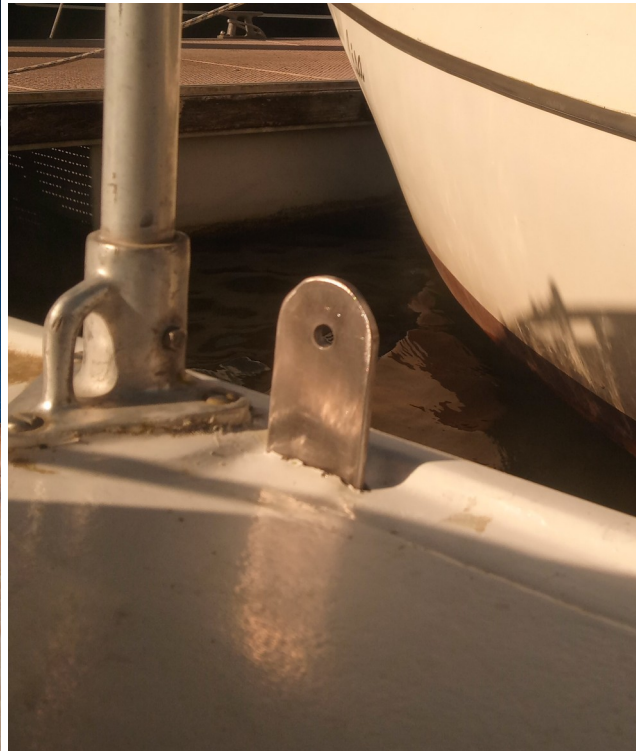
*New chainplate sticking through the deck*

First the original slots in the deck were enlarged to accommodate the larger steel bars. Pilot holes were drilled and enlarged to 10 mm diameter. The through-holes were then sealed with epoxy, and the bolt heads were also sealed with Sikaflex 291i (installed hand-tight until cured so the sealant does not squeeze out). The same was used to seal the slot in the deck. It sticks very well to a clean surface and stays flexible so it does not work open when the hull and deck flex a little.

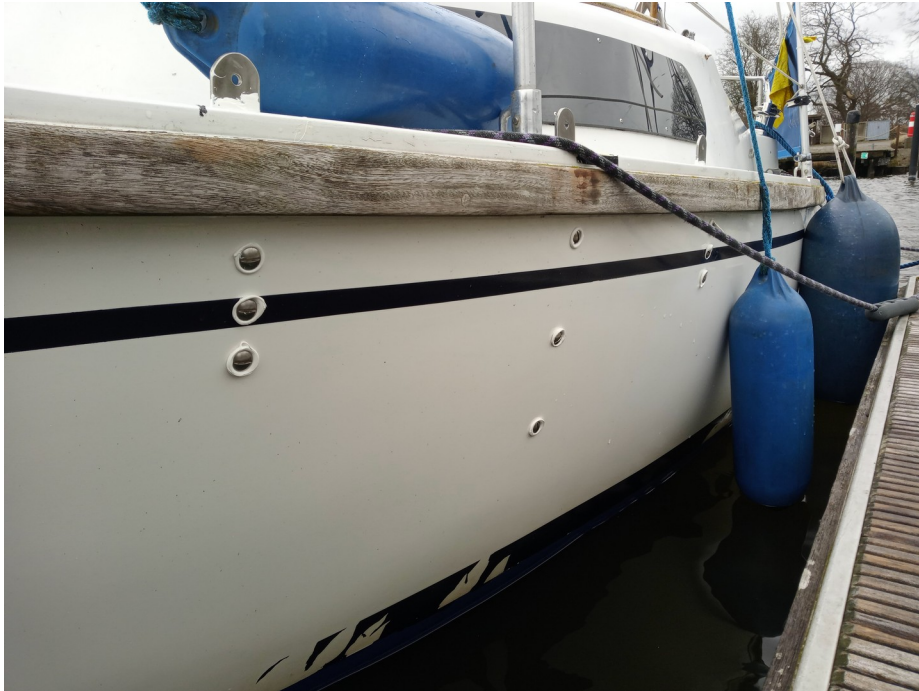
*Bolt heads showing the chainplate attachment.*

The new chainplates are extremely strong. The cross section is large, there are three instead of two bolts which are M10 instead of M6, and care was taken to position the holes for the shroud attachment well away from the rounded edges. The whole operation is certainly not much fun but gives great peace of mind, especially in heavy weather.

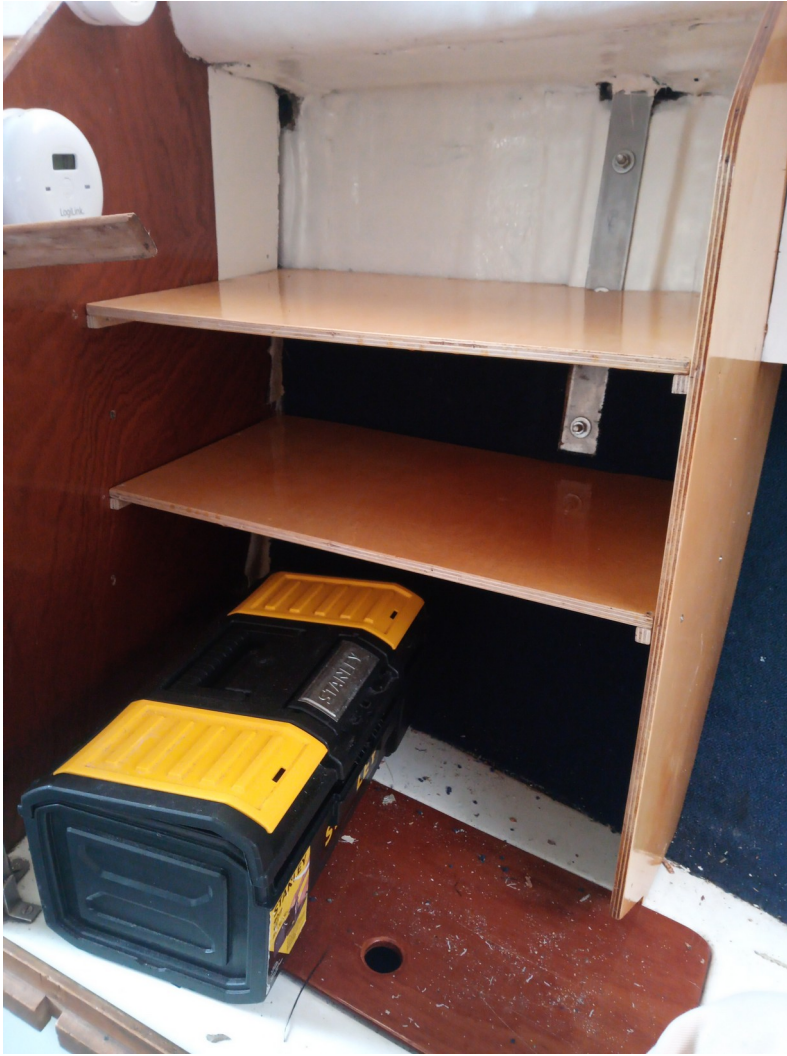
*Larger cupboard and new insulation installed after painting*
