WASHBOARD LEAKS

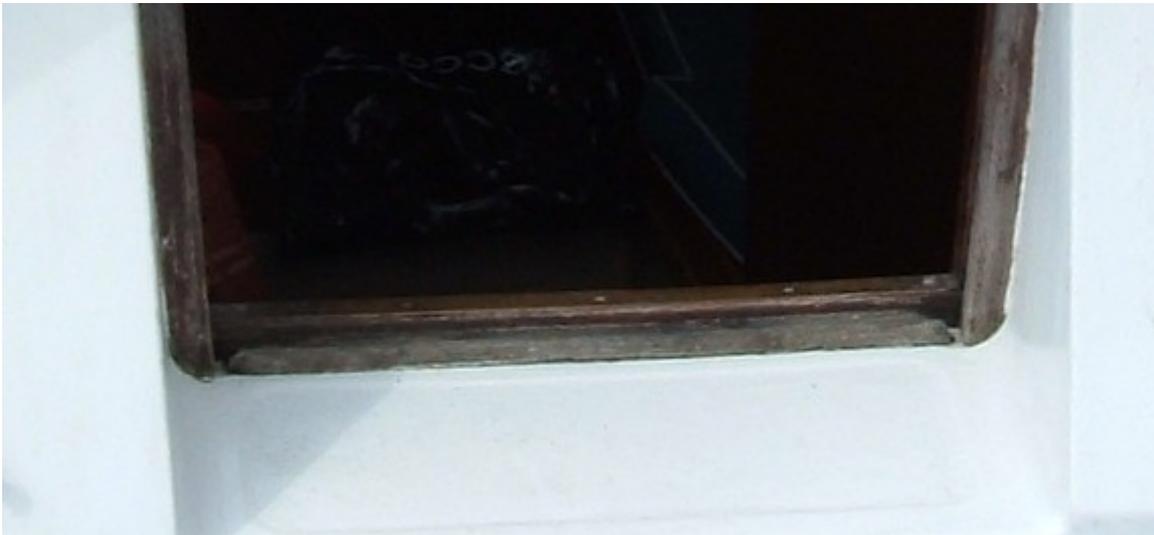
Eventually I discovered water running down the back of this bulkhead. The only place this could be getting in was from the washboard surround. As can be seen, the wood at the base had seen better days.

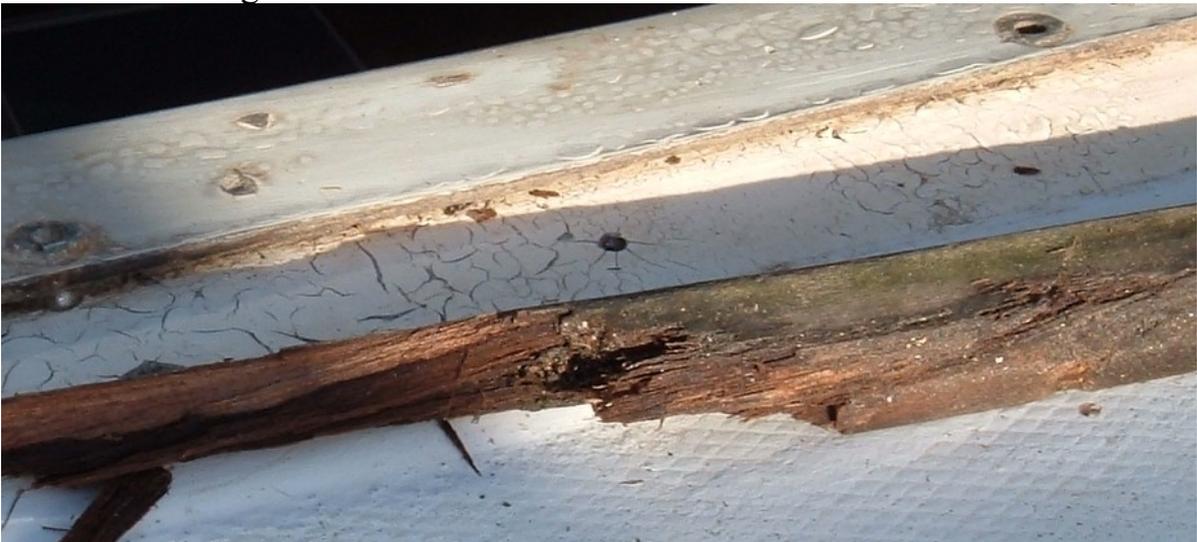
Once this had been removed, I was surprised to see that the internal bulkhead was just laid on top of the deck moulding. They were not glassed together, just 3 rivets and there was no sign of sealant.

The wood was also in worse condition than I had thought.
