## RUSTING BALLAST IN A FIN-KEEL HURLEY 22

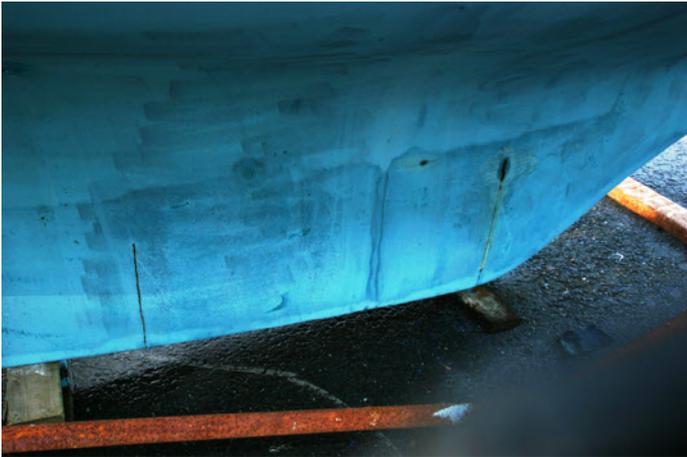
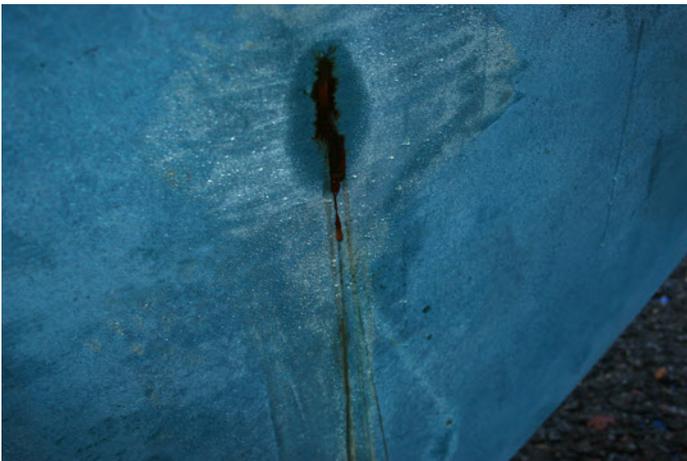
Figure 1 - tell tale signs

After about 3 weeks of my Winter 2011 lift-out, I noticed some alarming tell-tale signs on both sides of the keel (Figs 1 – 2). Streaks of rusty water were draining out of the – supposedly solid – keel. How on earth could this be happening? How serious a problem was it? I did not know but clearly it needed attention. Rusting of the ballast is potentially serious as the volume of material will expand with rusting, with possibly serious consequences for the hull.

After taking photos, I then proceeded to clean up the mess and to dry things out. I drilled out all the rusting spots on the outside of the keel, plus some additional holes at a lower level and allowed them to drain. A distressing amount of water drained out over a period of about 2 months. I recall that it had been a bitterly cold winter and that, maybe, the water in the keel had frozen and expanded, thus pressurising the pockets where it was trapped, causing the plugged holes to ‘start’ – i.e. leak.

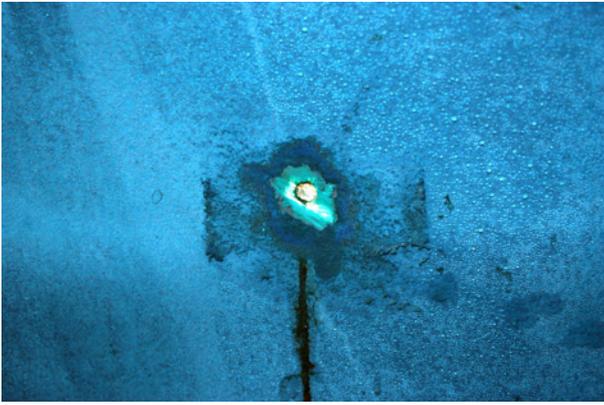
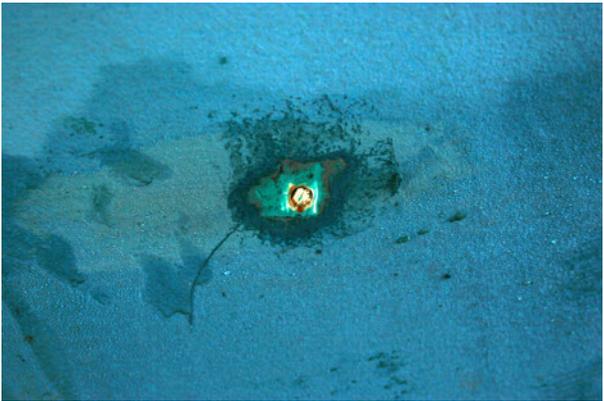
Figure 3

On scraping away the anti-foul and a layer of epoxy coating, each stream of rusty water was demonstrated to be coming from a small circular patch on the keel – about 1 cm is diameter (Figs 3 & 4). These looked as if a hole had been drilled in the keel at some time and then re-filled. The water was draining out around the edges of the fill. I don't know the reason for these holes but I do know that, in the mid-90s, the hull was blasted clean and coated in epoxy 'gel-shield' (pale green in the photos). It is my assumption that, at this time but for reasons which I can only guess at, a surveyor decided it was necessary to drill test holes in the keel. Maybe the rust problem was apparent even then.

Before filling with resin, of course, I had to leave the holes in the keel open to drain until no more water emerged, then dry and fill them. To fill the holes I used Sylmaster Aquastick epoxy putty, (<http://www.sylmasta.com/acatalog/TDS%20Aqua%20Epoxy%20Stick%2001.pdf>) which is ok in wet environments and easy to apply.

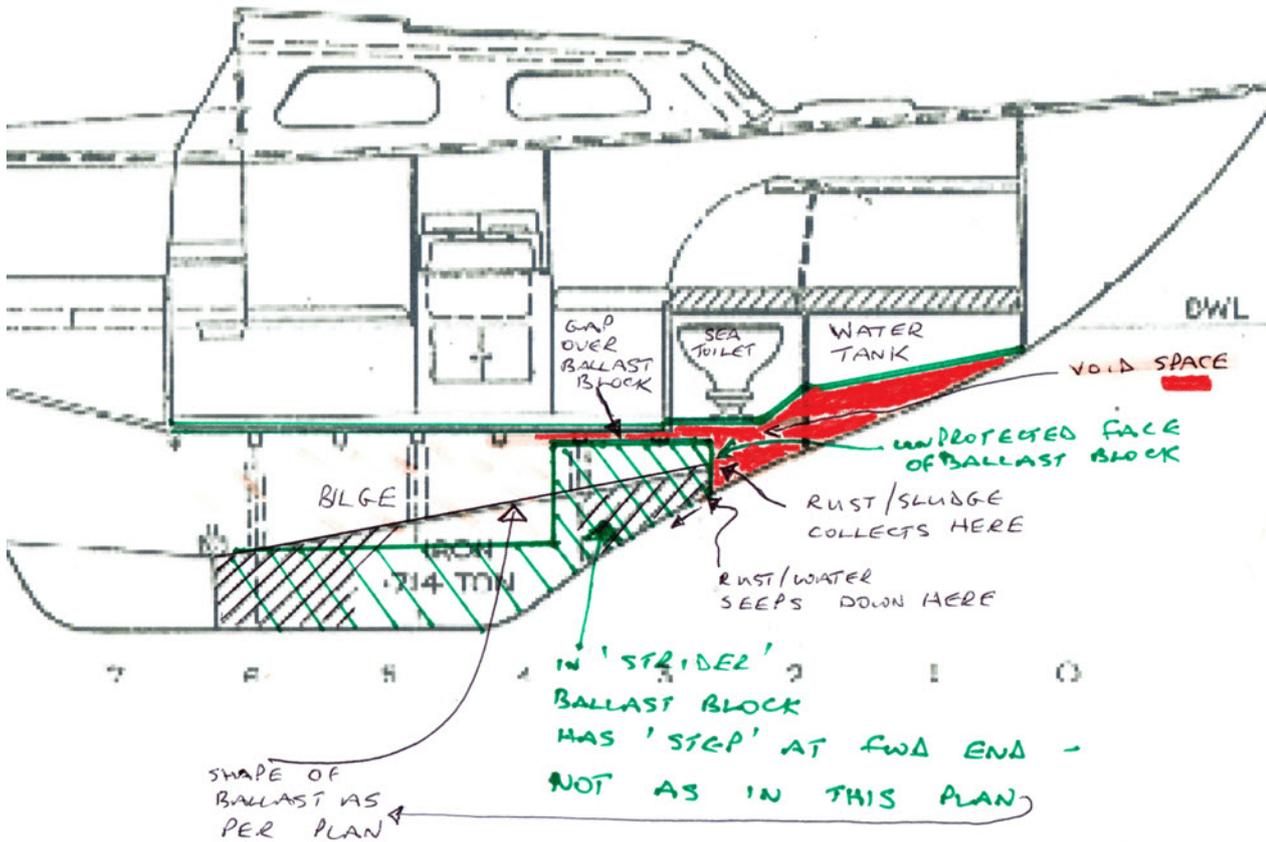
Figure 5

Checking in the bilge gave me no clue about what was happening but the answer was to be found in the sea-toilet compartment. At this point it will help you to study Fig 5. to understand the construction of the early 22s, especially those areas under the internal moulding which normally you cannot see.

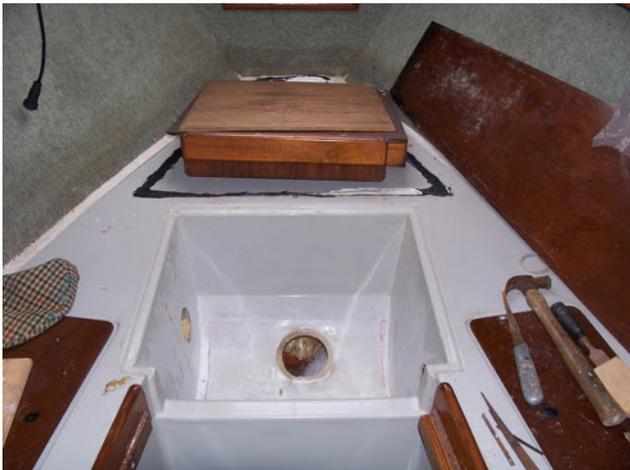
I had removed the sea-toilet in *Strider* shortly after buying her which made inspection easier. A previous owner had, again for unknown reasons, cut a circular inspection hole in the bottom of the compartment through which limited access could be gained to the void space which exists under the sea toilet and into which the forward edge of the cast iron ballast block faces. See Figure 6.

Figure 6 Sea-toilet compartment

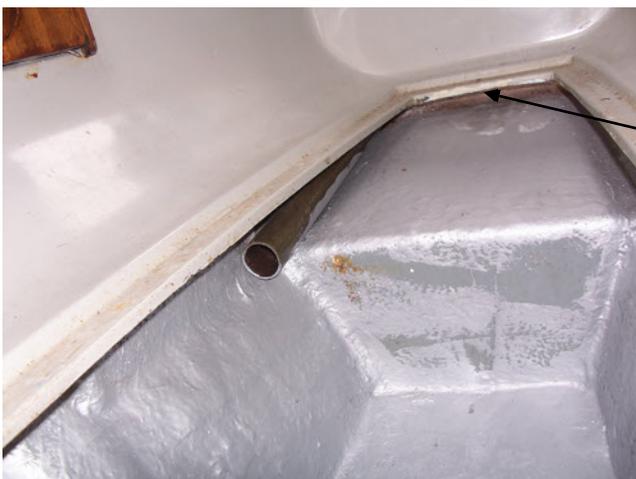
If you squat in the bilge and face forward you will be looking at the forward section of the ballast block (coated in resin) which forms a step about 9 in high at its forward end. With a length of bendy batten pushed forward (or your fingers) - over the ballast and under the internal moulding – you can demonstrate that there is a gap between them. See Figure 7.

Gap under here

Figure 7 In bilge, looking forward. Stepped forward section of ballast block visible plus the gap above it

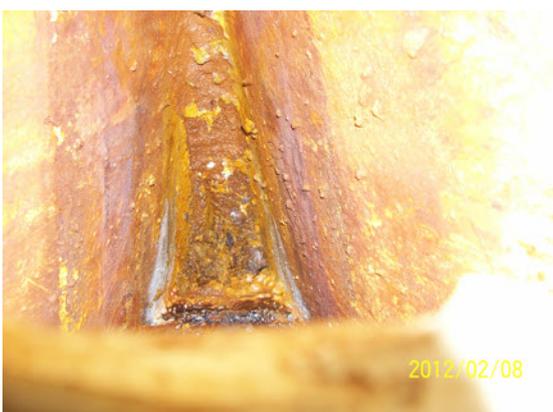
So if you get water in the bilge it could slosh around and penetrate forward, over the top of the ballast block, to sit in the void space. This would not be a problem if the ballast block were fully encased in resin. When I peered into through the inspection hatch, it seemed rather messy and rust coloured. When I put my hand through as far down as it could go – my fingers were quickly immersed in wet, oozy, rusty sludge. Yuk! See Figure 8.

2012/02/08 Figure 8 Rusty sludge visible through inspection hole

The quantity of rust sludge was such that the source could only have been the cast iron of the ballast block, which for unknown reasons, was not protected by encasing in resin. This water and rust sludge was sitting in the lowest part of the hull moulding, as it runs down the leading edge of the keel, surely this was the source of the rusty water now finding its way to the outside world! The rusty water must have been running down between the ballast and the hull moulding – in those (presumably) tiny spaces where the encapsulating resin had not penetrated.

The work above turns out to be something of an 'own goal'! The source of water in the void space was almost certainly the fresh water tank. In Strider there is a hole in the tank, port side, about an inch from the top, where the hose passes through on its way to the pump. When I renovated the tank several years ago, I sealed the space around the hose with Sikaflex. However, this had perished and there were gaps between the hose and the wall of the tank, though which both air and water were passing. The water was finding its way into the void space, by a route under the main moulding, which you cannot see. Also, I believe that when filling the tank, air was exiting through the gaps around the hose, resulting in the tank filling to the top - and then water being forced into the void, by the head in the filling pipe. All avoidable!

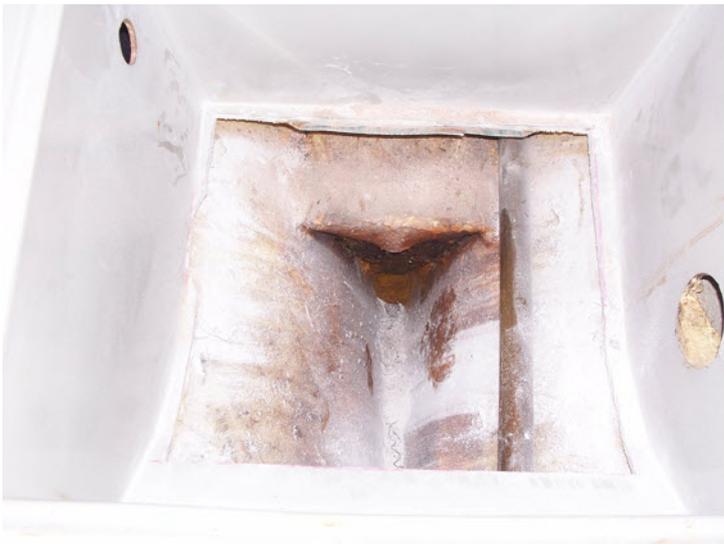
See Figure 9 for the results of this. I have to say that I was impressed by the strength of the internal moulding. Also note that the sea-toilet compartment floor is reinforced with ½ in ply. I managed to just cut into this (because you cannot see where the ply begins...) – which made life rather harder.

Figure 9 Void space under sea-toilet floor. Front of ballast block visible. View looking aft. Reinforcement with ply just visible at top of picture.

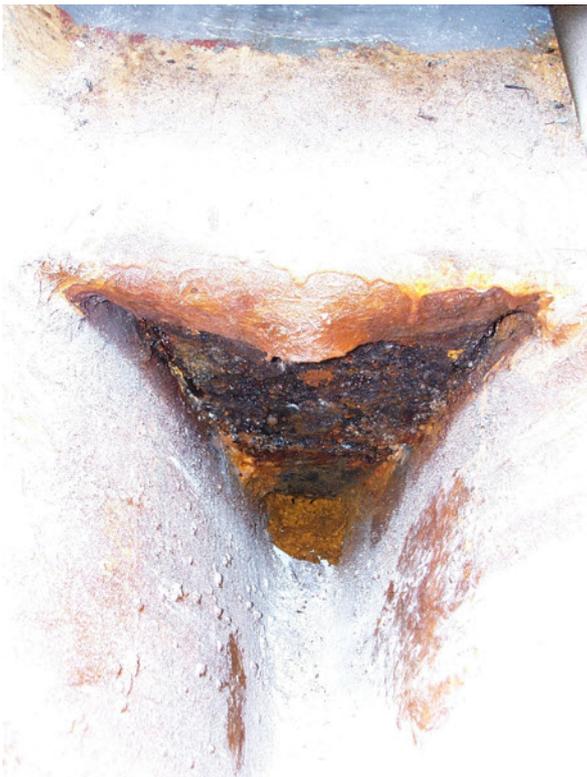
I had to enlarge the cut in the GRP in order to actually get the floor out but finally it came – and revealed the full horror! See Fig 10.

Figure 10 close-up of rusty front face of ballast block (looking aft). White dust is resin, resulting from cutting out sea-toilet floor.

The forward section of the ballast block is clearly visible – poking into the void space under the sea-toilet. The block was covered with chopped-strand mat and resin on the top and sides – but not the forward face – a triangle of sides about 4 – 6 inches and going right down into the lowest part of the keel. This face was severely rusted. With a hammer and chisel I cut back the GRP/mat on the top of the block for about 3 inches back from the front edge, to expose the extent of the rust. See Figure 11.

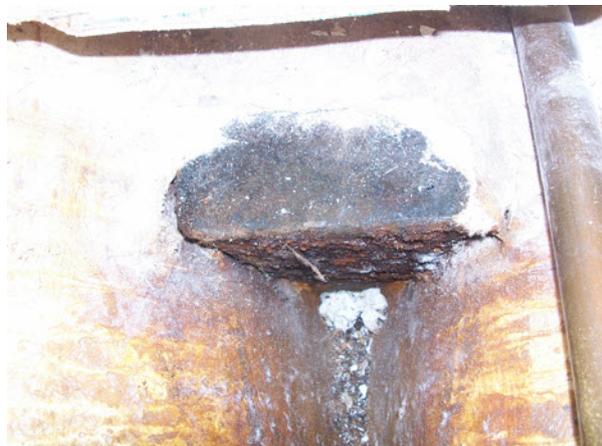
Figure 11 Top few inches of ballast block – GRP mat removed to expose area of rust

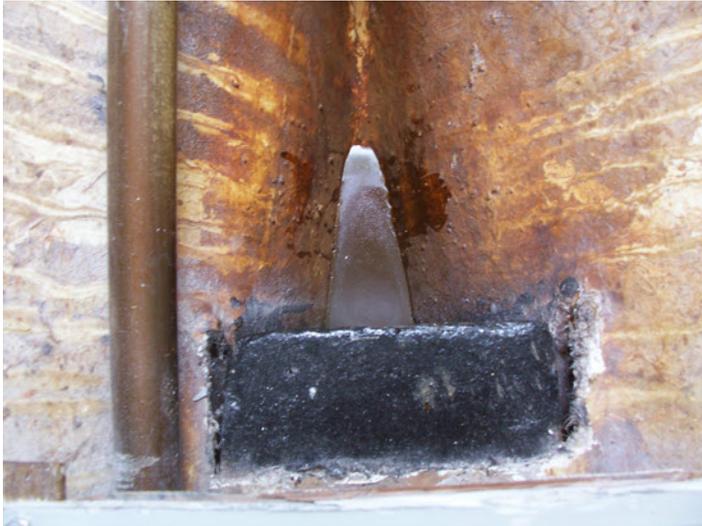
Figure 12 Front of ballast block painted with Hammerite and initial fill of casting resin – reaching a few inches further forward.

I consulted Nick Vass who kindly came down to look and advised me on filling the space with resin – once all was as dry as it could be. The theory is to fill the space with polyester casting resin, which would drain down into the lowest void spaces between the ballast and the hull moulding, thus sealing everything and preventing any more water getting down there. Note that casting resin cures slowly and therefore does not heat-up or expand much and is therefore best for this application. We thought that the resin would actually get as far as the holes in the keel and drain out – thus proving that the whole ‘drain path’ had been filled. In the event this was not the case, so I may have poured resin over residual rust deep inside the keel – but there was nothing else to be done.

Initially, I poured resin into the lowest part of the void space, so that it just started coming up the face of the ballast block – but only just – and also to a point a few inches forward of the ballast. See Fig 12

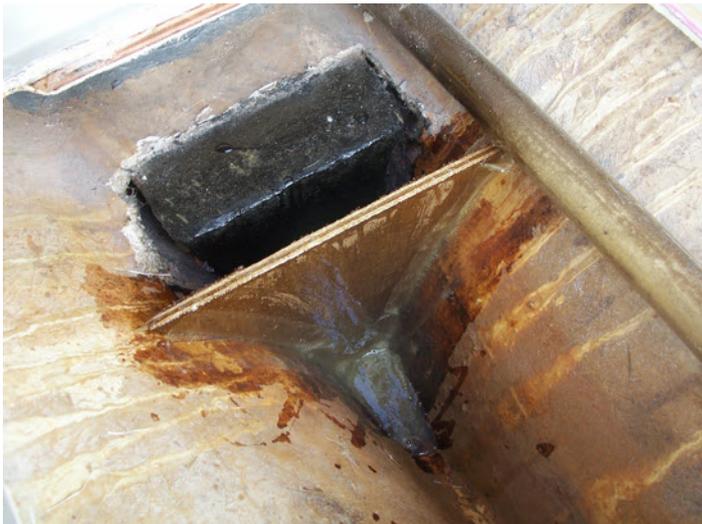
Figure 13 ‘Cofferdam’ glassed-in just ahead of ballast block

In order to keep the costs down and minimise the quantity of resin needed, Nick advised me to install a ‘cofferdam’ – basically a small bulkhead, just ahead of the ballast block. This I fashioned out of plywood and glassed into place with woven glass strip and epoxy resin on top of the first layer of resin (see Fig 13). Although it was a bit rough and ready, once fixed firmly, pouring the second batch of resin on the ‘after’ side of it, sealed everything up nicely.

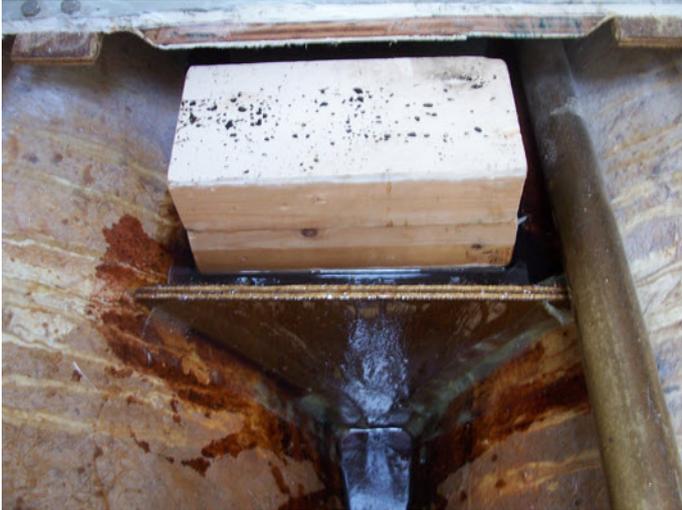
Figure 14 4 x 2 supports for sea-toilet floor, captured in the second fill of casting resin, which has flowed all round the ballast block, top and sides, up to the top of the cofferdam.

In order to provide a solid bed for the sea-toilet (having reduced the strength of the compartment floor by cutting it away), I placed two blocks of 4 x 2 timber on top of the ballast block, having confirmed by measurement that they would sit just under the sea-toilet floor and provide a direct foundation on top of the ballast. I then proceeded to fill up the whole of the space ‘aft’ of the cofferdam with resin. The resin came up and over the top of the exposed ballast block (which I had previously rubbed down and treated with Hammerite) and around the 4 x 2 blocks, thus making a complete seal of the ballast (see Fig 14) – something which the Hurley team should have done in 1968!!

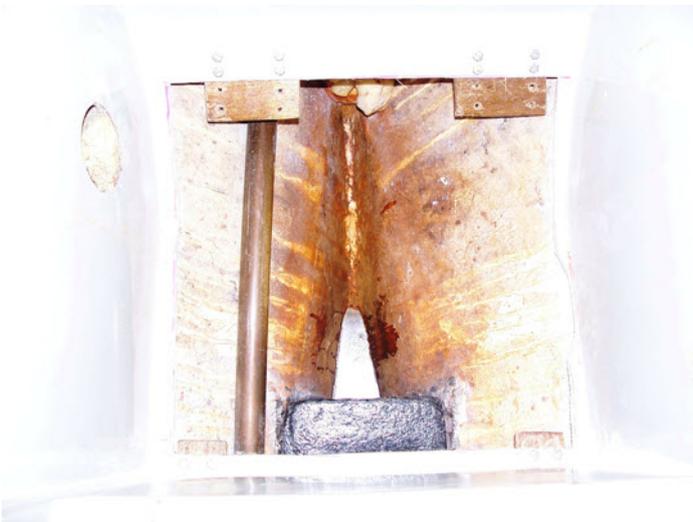
Figure 15 Plywood brackets bolted to internal moulding, to support sea-toilet floor

Once all was complete, I fashioned some small pieces of plywood as brackets and, with SS bolts, reinstalled the sea-toilet floor. See Figure 15.
